2015 CASE STUDY

Type: Residential | Issue: AL201503

Helical Piles
Provide Maximum
Practical Recovery
to Two Homes in a
Neighborhood
Restoration Project

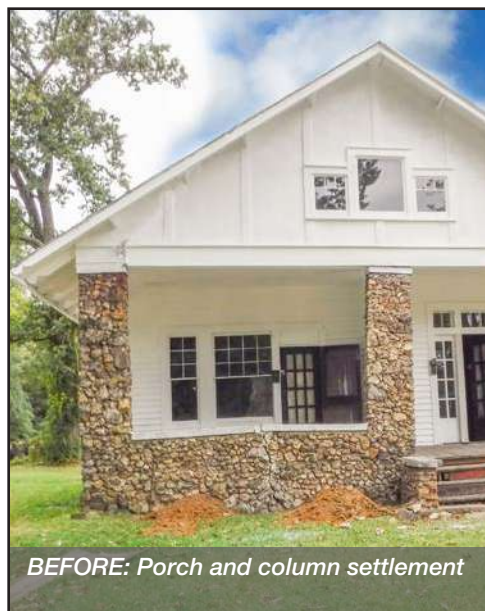
Two of the Woodland homes undergoing restoration had severe foundation problems, evidenced by the settlement of their columns and front porches. An engineering firm proposed to repair the structures' foundations with steel helical piles. The vintage columns were composed of mortared stone, making them particularly vulnerable to failure when lifting.

BEFORE: Porch and column settlement

Alabama Ram Jack installed seven helical piles at the two properties, lifting the structures an average of 2 in. for maximum practical recovery. This created level front porches as well as straightening the sagging support columns. Alabama Ram Jack finished the job without any issues, much to the satisfaction of the restoration company.

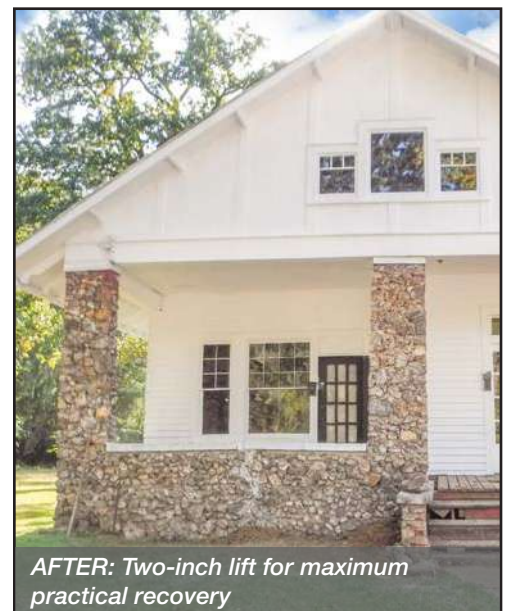
AFTER: Two-inch lift for maximum practical recovery
