2014 CASE STUDY

Type: Residential | Issue: AL201405

STABILITY RETURNED TO HOME BUILT ON A STEEP SLOPE

Restoring the Solid
Foundation of a
Brick Home

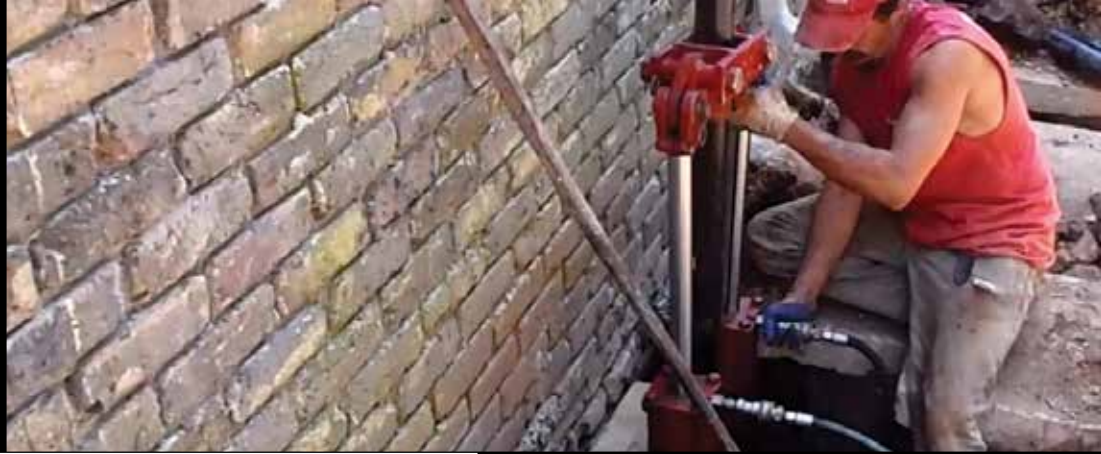
HOME BUILT ON STEEP SLOPE

The foundation in the rear of the home had experienced significant settlement, pulling laterally away from the home and creating gaps between the basement floor and walls. Built on a steep slope, the home's construction created unique problems. Not only had the footings pulled out, but they also pulled down due to the angle of construction. The

settling foundation created not only a cosmetic problem but also created safety concerns, as the structural stability of the home was in question.

Alabama Ram Jack proposed using a combination of 12 driven piles and 12 helical tie-back piles to provide vertical support to the foundation as well as to prevent any outward movement. Eight (8) new construction helical piles would also be replaced to support a to-be-built rear deck that would replace the deteriorated existing one.

The professionals at Alabama Ram Jack completed the plan as proposed, lifting the foundation over 1 in. using 32 total piles installed to an average depth of 12 ft. Maximum practical recovery was achieved. Ram Jack's solution also provided an even base for the construction of a new deck and the structural strength the home needs to remain stable for years.

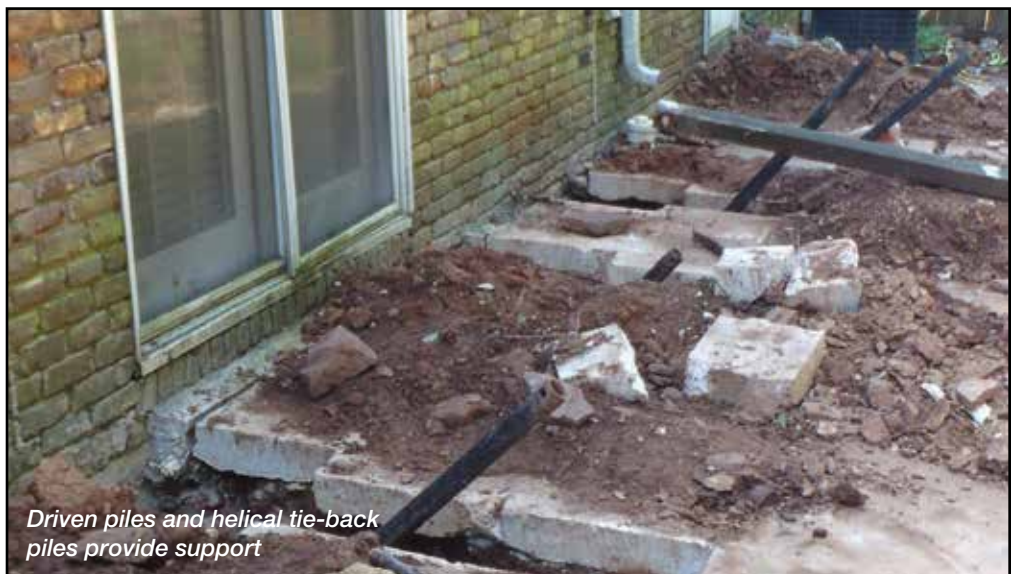
Driven piles and helical tie-back piles provide support
